Time Critical Repairs in Alaska

In Cordova, Alaska, five-year-old U.S. Coast Guard family housing units experienced significant water leakages, causing mold and rot, and requiring immediate restoration work.

By Karina Quintans, M.S.A.M.E.

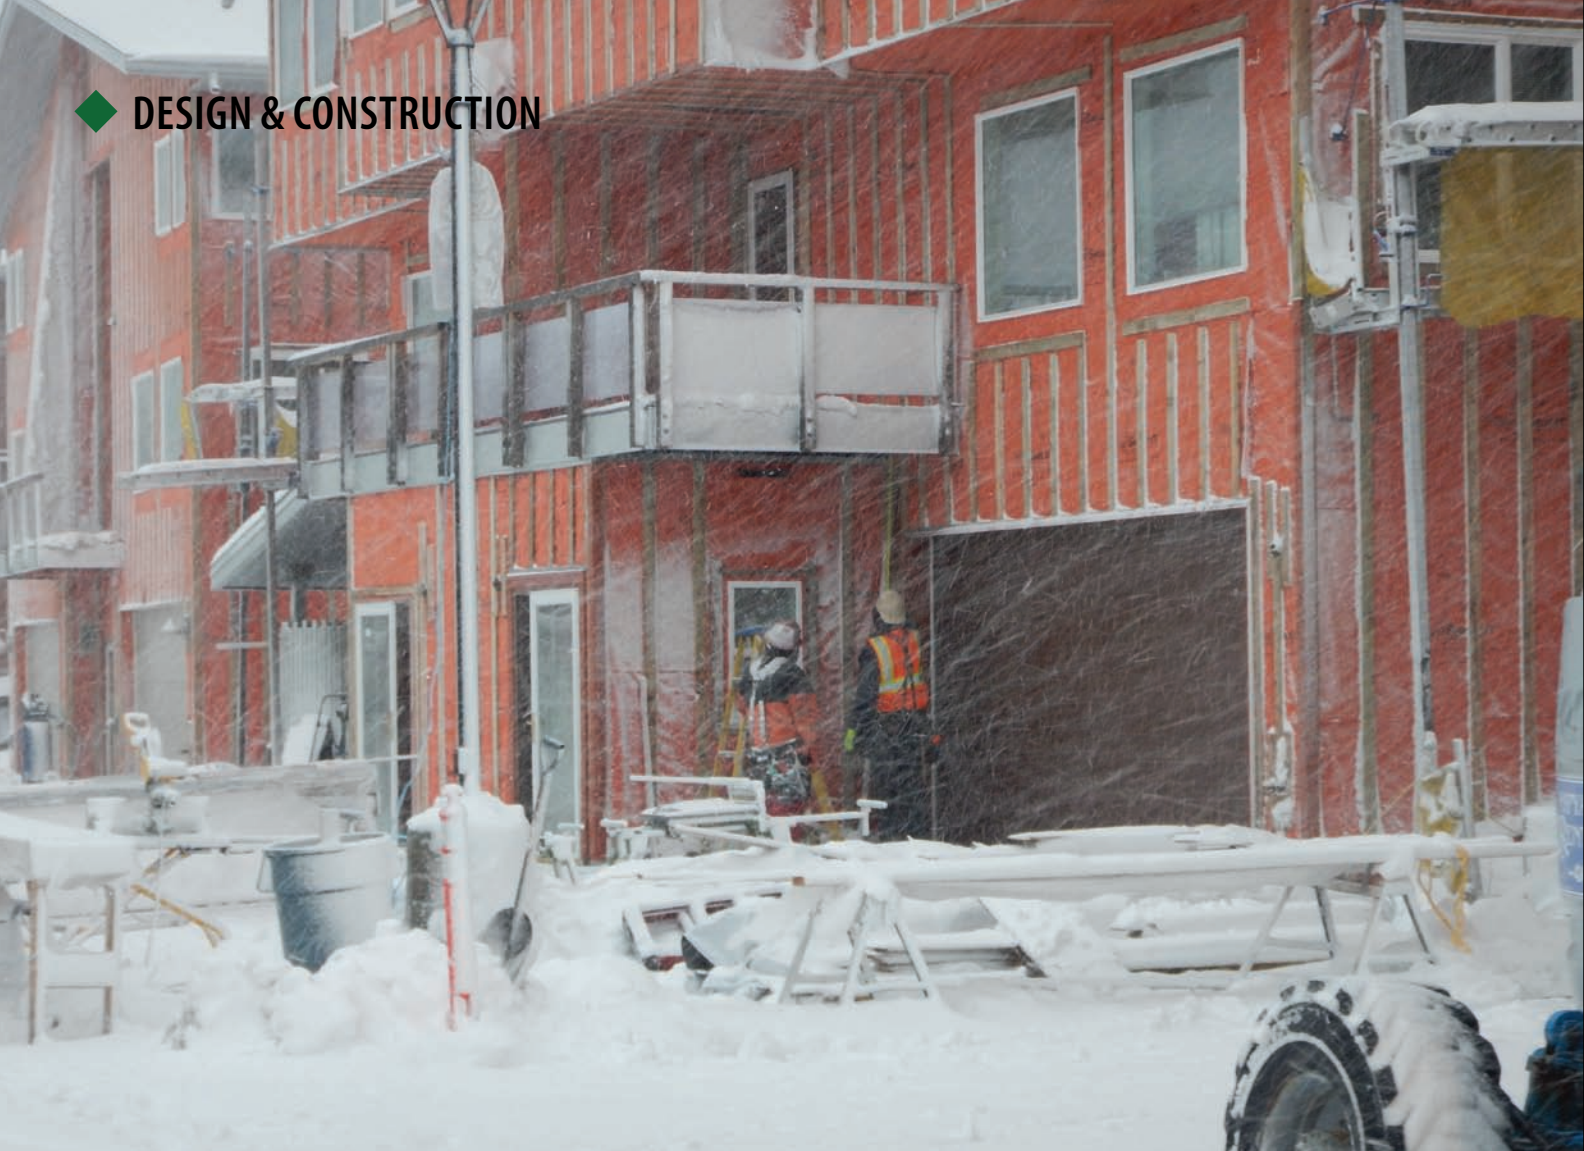
With an oceanic climate, Cordova experiences year-round precipitation, with no real dry season to perform construction. PHOTOS COURTESY AHTNA ENGINEERING SERVICES

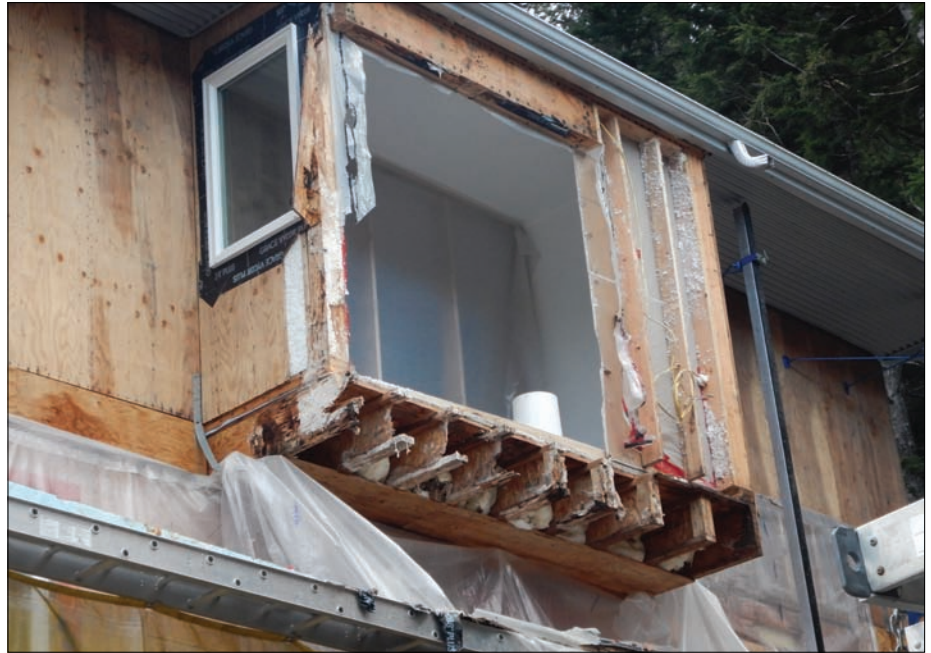
In assessing the damage to the housing units, the Coast Guard confirmed high levels of humidity, indicating a risk to human health from mold and the possibility of structural failure from rot.

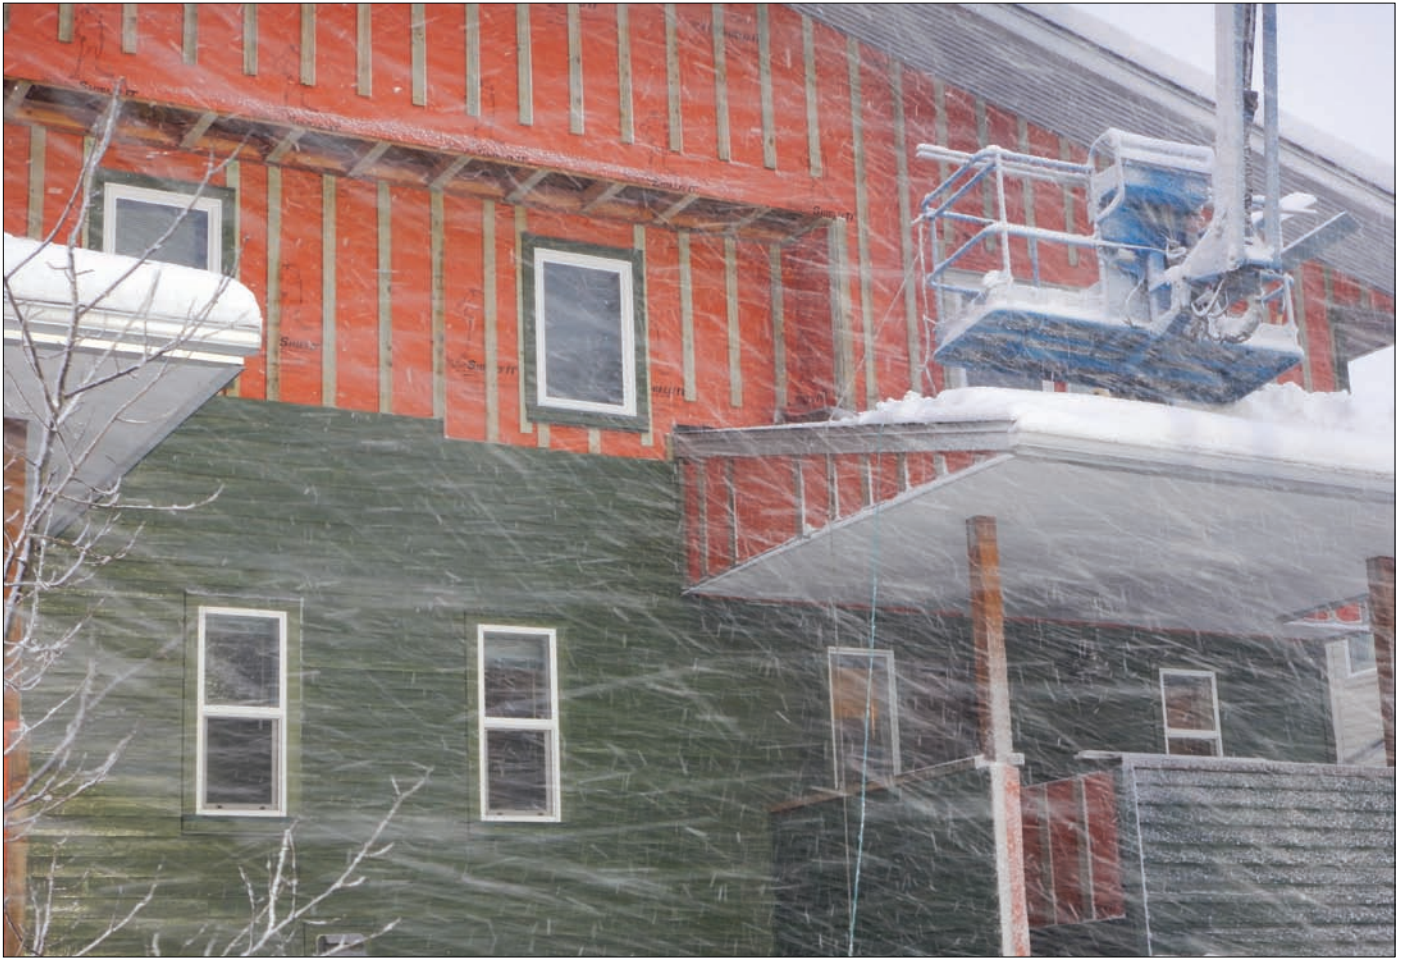
The field team worked throughout the rain, snow and icy conditions without a safety incident and with no major work stoppages due to extreme weather.
